# Corrosion

devoted entirely to  
**CORROSION**  
research and control

Hydrogen Sulphide Corrosion Cracking of Steel By L. W. Vollmer	326
SYMPOSIUM ON SULFIDE STRESS CORROSION	
Stress Corrosion Cracking of Steel Under Sulfide Conditions By C. N. Bowers, W. J. McGuire and A. E. Wiehe	333
Cracking of High Strength Steel in Hydrogen Sulfide Solutions By J. P. Fraser and R. S. Treseder	342
Field Experience With Cracking of High Strength Steel in Sour Gas and Oil Wells A Report of TP-1G	351
Hydrogen Embrittlement Tests on Various Steels By F. A. Prange	355

## Symposium on SULFIDE STRESS CORROSION

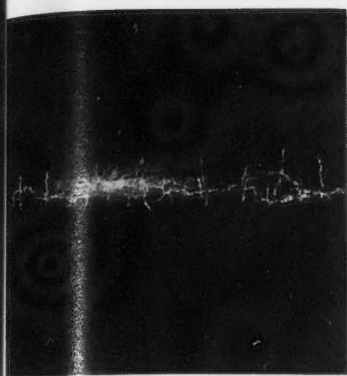
THIS MONTH'S COVER—Zygo, a fluorescent penetrant developed by Magnaflux Corp., Chicago, has indicated here corrosion cracks in a nickel oil refinery still tube. It was known several tubes in the still were leaking and the fluorescent penetrant permitted identification of the faulty ones. This is an illustration from a technical paper presented at South Central Region's New Orleans meeting on the uses of this inspection method.

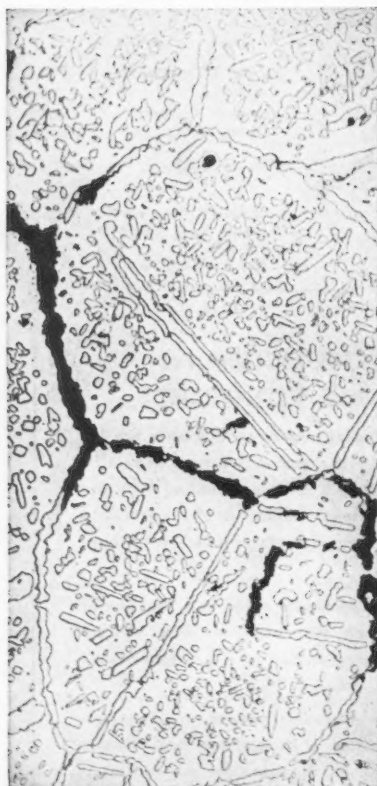
Under the microscope, this specimen reveals the reason why a carburizing box broke after 2200 hours of service at 1860° F. The thick black lines are the hard carbides which intruded along the grain boundaries and oxidized, causing embrittlement of the metal.

This is one form of destruction that can be caused by carburization.

It may be a tolerable condition in some applications. Where the metal is subjected to impacts or sudden temperature changes, however, carburization can be the reason for premature failure.

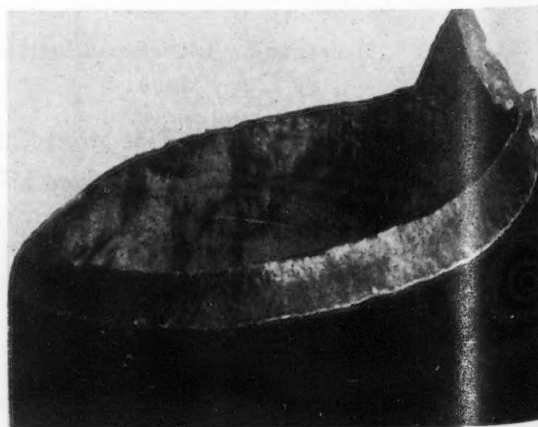
Figure 1—One half of first tubing failure, 26 feet from surface.

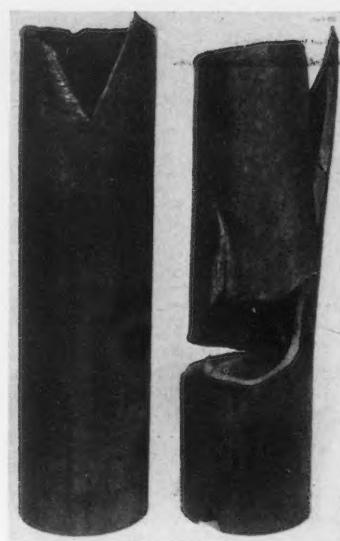
Figure 3—Both ends of second failure occurred at 1201 feet from surface.

While fishing, the tubing parted again at 1201 feet under a load of 80,000 to 85,000 pounds at approximately the midpoint of the joint. Both halves of this failure are shown in Figure 3.

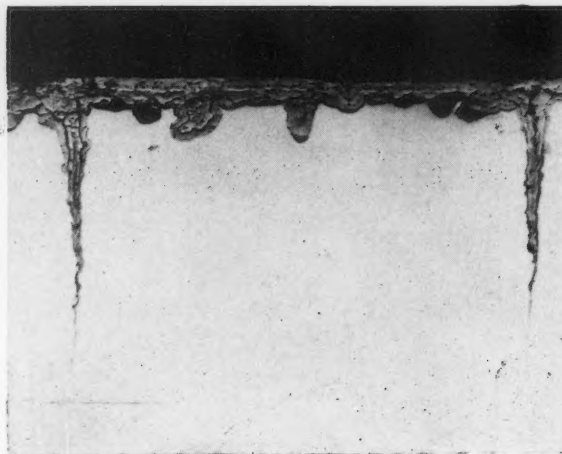
Figure 4—Stress corrosion cracks in 9 percent nickel steel beam specimen (fiber stress 70,000 psi) after 306 days in corrodent. (Unetched).

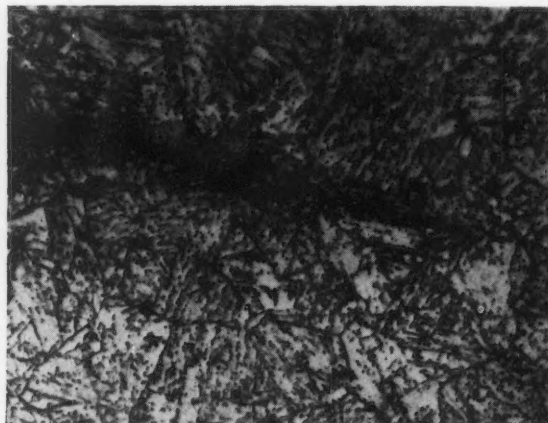
Figure 5—Portion of one of cracks in Figure 4. It is predominantly transgranular. Nital. X 1000.

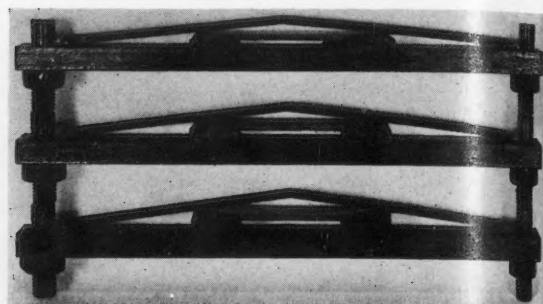
Figure 8—9 percent nickel steel stress-corrosion cracking failures.

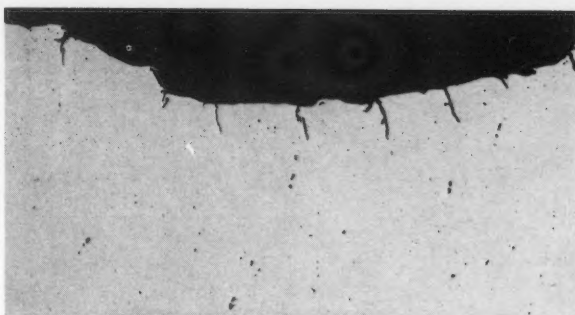
Figure 9—Small cracks originating at and perpendicular to main fracture faces.

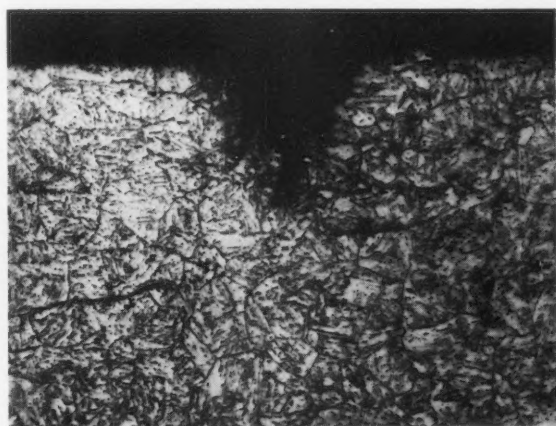
Figure 10—Cracks starting at pits in stress-corrosion cracking specimen. Note small stringers of non-metallic inclusions. Nital etch. X 500.

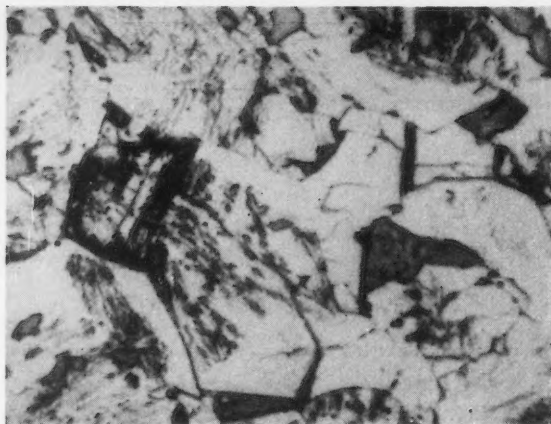
Figure 11—9 percent nickel steel structures after annealing followed by tempering at 800 degrees F. Hardness of dark constituent is 500-550 Brinell. Nital etch. X 2000.

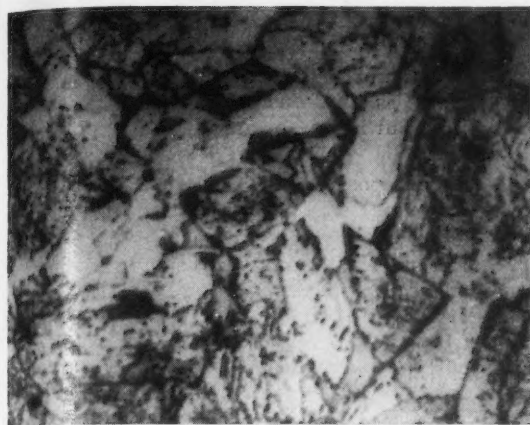
Figure 12—Structure near first tubing failure showing dark constituent at some grain boundaries. Nital etch. X 2000.

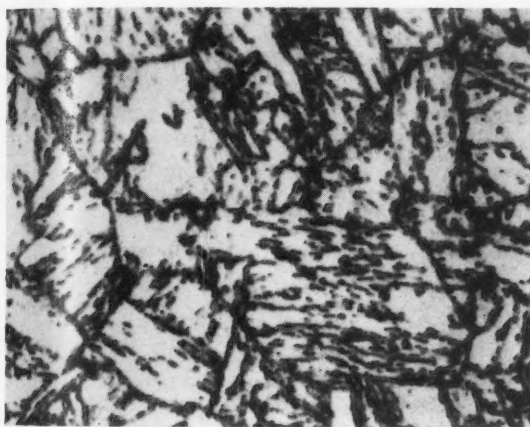
Figure 13—9 percent nickel steel double normalized 1650-1450 degrees F, tempered two hours at 1100 degrees F. Dark etching constituent is absent. Nital etch.

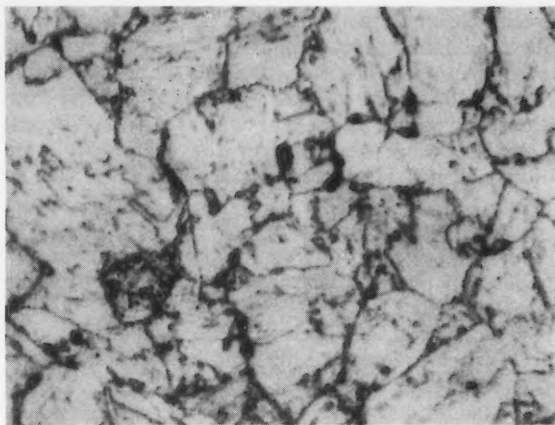
Figure 14—Structure of 9 percent nickel steel with 0.300 percent titanium. Dark constituent is absent. Nital etch.

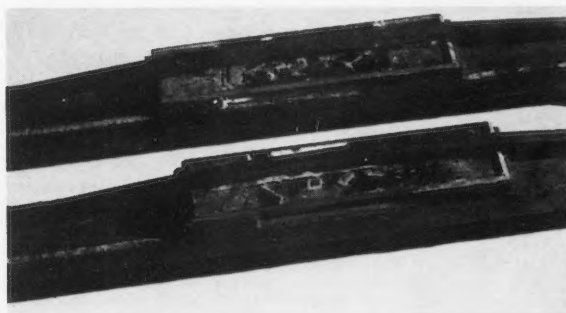
Figure 15—9 percent nickel steel beam specimens after 272 days; tap water saturated with carbon dioxide. Specimen loaded up to 120,000 psi shows more corrosion in 4-inch high-stress zone.

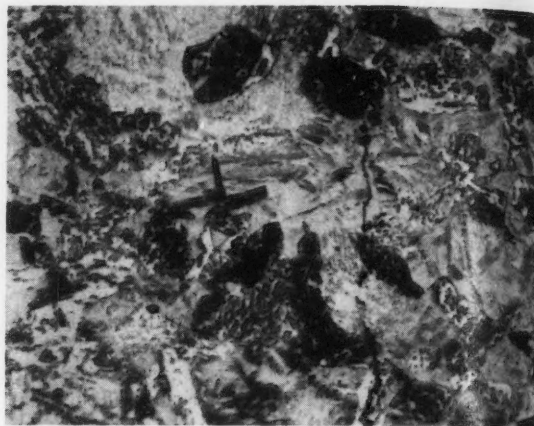
Figure 6—Crack in martensitic structure of Grade N-80 steel with high manganese content and a hardness of Rockwell C-28 (Test 39). This constituent appears as a network at lower magnification. Nital + picral etch, X 1000.

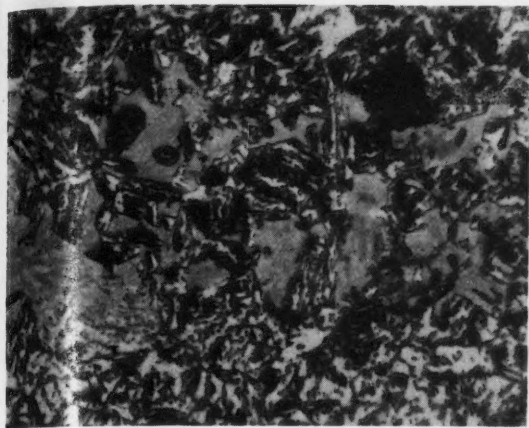
Figure 7—Martensite in Grade N-80 steel (Test 47). This constituent appears as a network at lower magnification. Nital + picral etch, X 1000.

All of the steels that failed showed the presence of martensite in some degree of temper, usually in the form of a continuous phase or network. This constituent is shown in Figure 6 which is the structure of the Grade N-80 steel (Test 39) with the higher than normal manganese content and a Rockwell hardness of C28. (Note the fine crack in the martensite.) Tempering this steel at 1000 degrees F, which reduced the hardness to Rockwell C24, did not alter the martensitic network or temper it sufficiently to prevent early failure in the specimen prestressed to the tensile strength and loaded to 80 percent of the yield strength (Test 44).

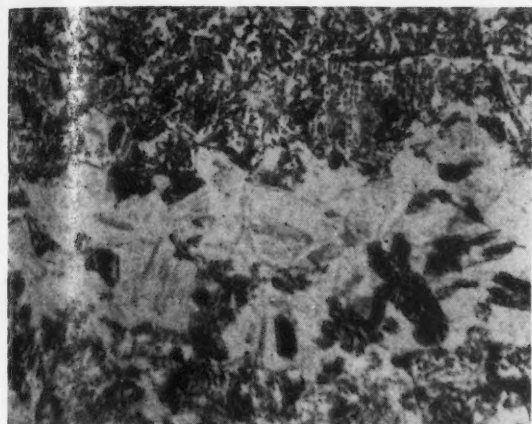
Figure 8—Maximum martensitic condition in substitute Grade N-80 steel (Tests 61 to 64). This constituent was not present generally as a continuous network. Nital + picral etch, X 1000.

The structure of the substitute Grade N-80 steel in Tests 61 to 64 is shown in Figure 8. This represents the maximum martensitic condition present. For the most part there were only minor amounts of the constituent found and these did not appear nearly so much as a network as did the martensite in the

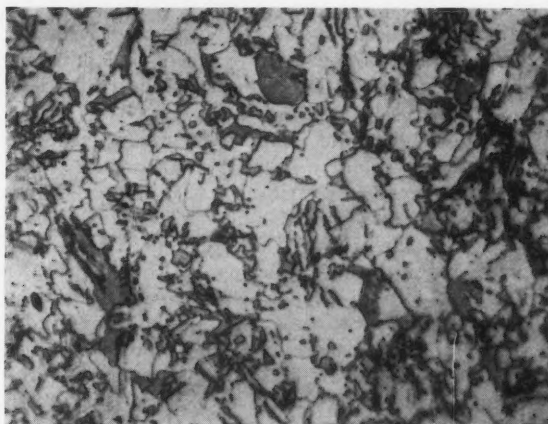
Figure 11—Fully tempered low carbon martensite with spheroidized carbides in 9% chromium-1% molybdenum steel. Nital + picral etch, X 1000.

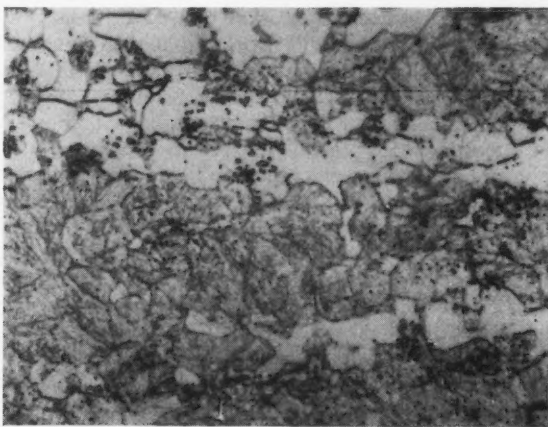
Figure 12—Segregation of martensite in 12% chromium steel (Test 27). Nital + picral etch, X 1000.

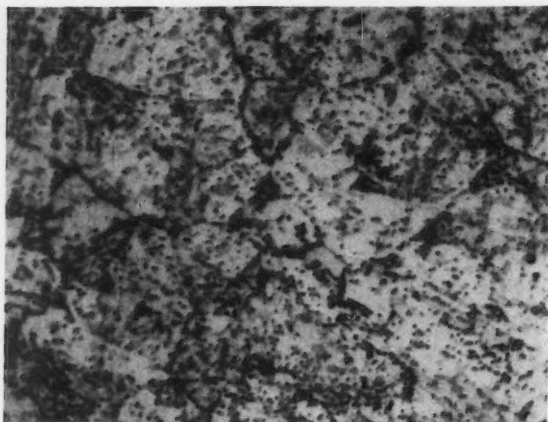
Figure 13—Dark etching constituent in structure of 5% nickel—1% chromium steel. Nital + picral etch, X 2000.

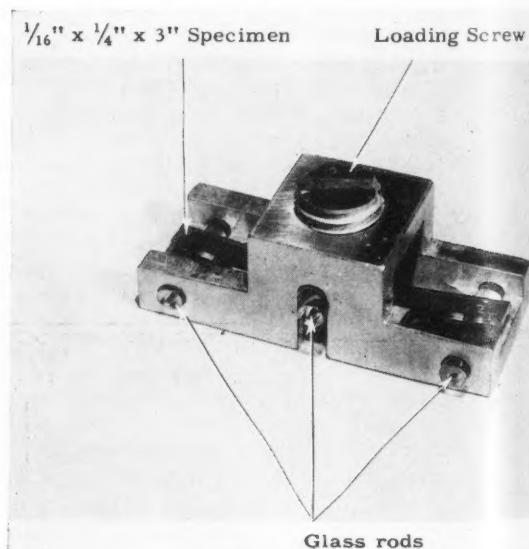
Figure 1—Holder for constant-deformation stressed specimens.

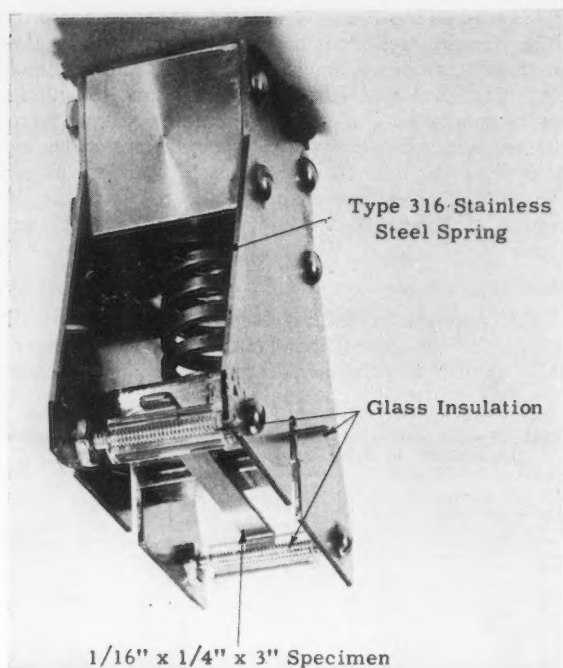
Figure 2—Holder for constant-load stressed specimens.

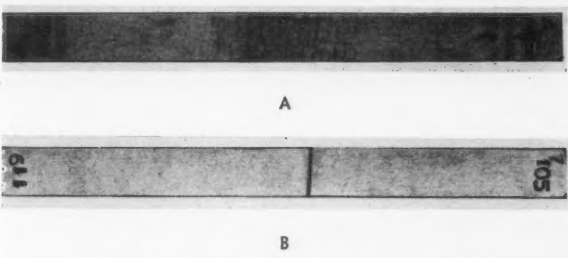
Figure 4—Comparison of stress corrosion cracking with sulfide corrosion cracking—macroscopic aspects. A. Stress corrosion cracking of N-80 steel. Two days' exposure to 0.7 percent HCN, air atm., 20-25 degrees C. B. Sulfide corrosion cracking of N-80 steel. One-day exposure to 0.5 percent acetic acid, H<sub>2</sub>S atm., 20-25 degrees C.

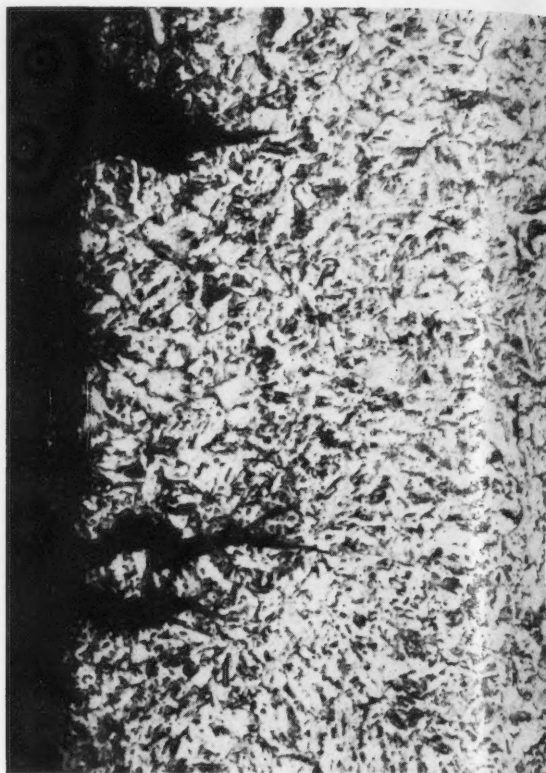
Figure 6—Typical pitting associated with sulfide corrosion cracking of N-80 steel. Tension side of specimen. Six days' exposure to  $H_2S$  atmosphere, 0.5 percent w. acetic acid solution, 20-25 degrees C. Etchant 1.5 percent Nital, X 500.

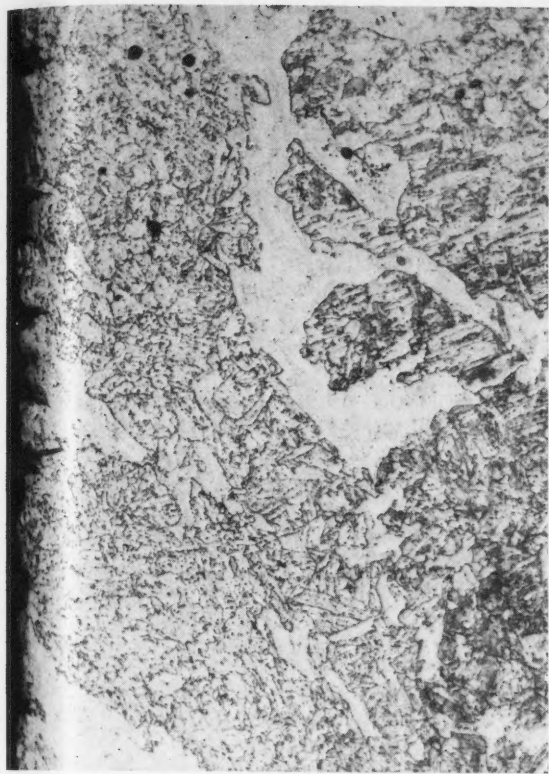
Figure 7—Typical pitting associated with sulfide corrosion cracking of cast 12 percent chromium steel. Tension side of specimen. Six days' exposure to  $H_2S$  atmosphere, 0.5 percent w. acetic acid solution, 20-25 degrees C. Etchant Marble's reagent, X 250.

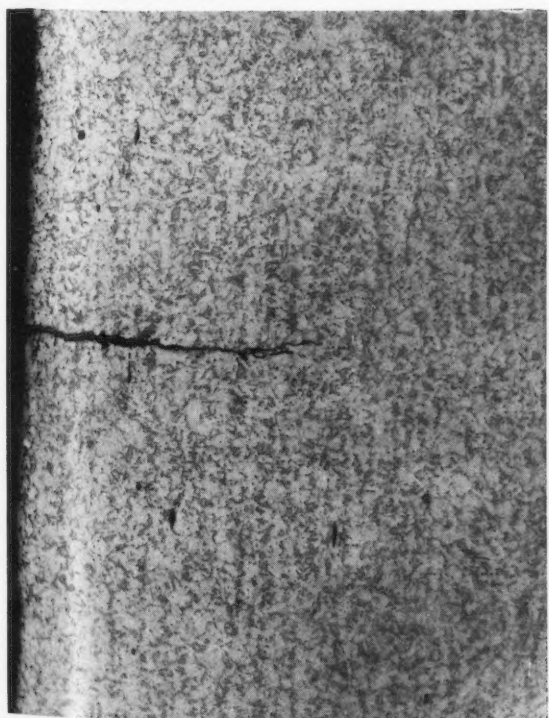
Figure 8—Sulfide corrosion crack in 5 percent nickel steel. Tension side of specimen. Six days' exposure to  $H_2S$  atmosphere, 0.5 percent w. acetic acid solution, 20-25 degrees C. Etchant, 1.5 percent Nital, X 250.

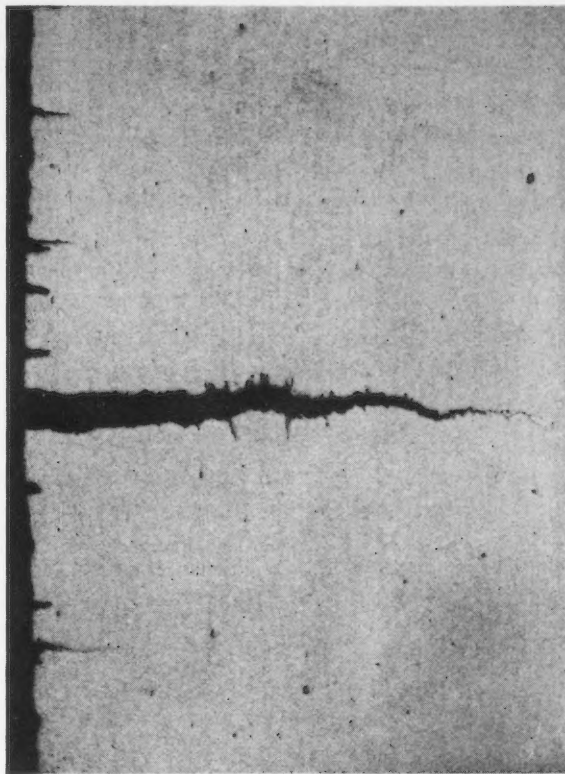
Figure 9—Typical sulfide corrosion cracking of 9 percent nickel steel. Specimen exposed five days in 0.5 percent w. acetic acid solution,  $H_2S$  atmosphere, 80 degrees C. Etchant, 4 percent Nital, X 50.

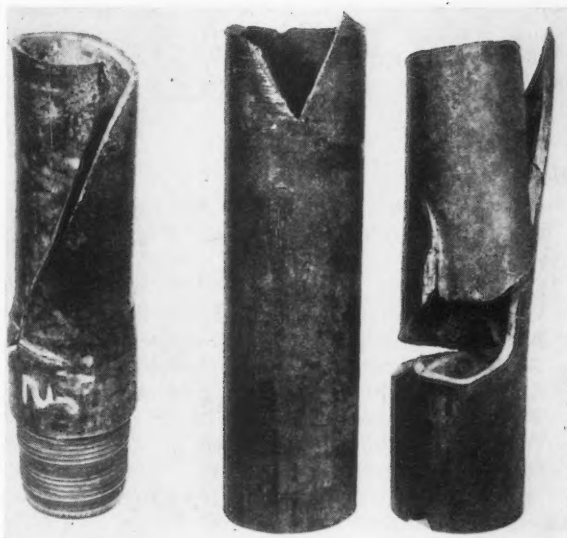
First Pincher Creek failure occurred at 14 inches from upset at depth of 26 feet.

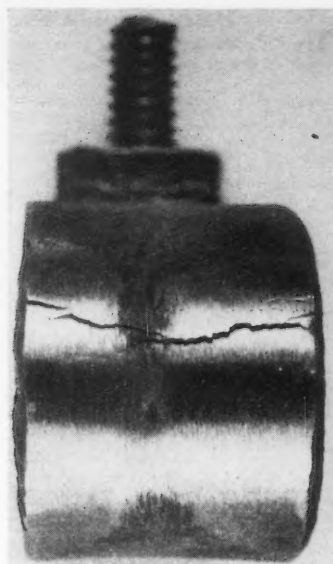
Figure 1—Cracks in cathodically pickled 9 percent nickel steel. 3X.

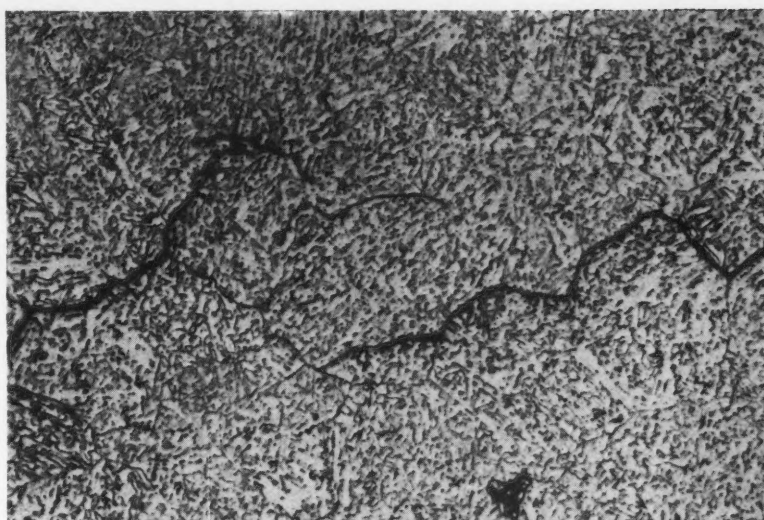
Figure 2—Cracking in a 9 percent nickel tubing sub which failed in a sour condensate well after a few hours' service. Amyl alcohol—nitric acid etch. 200 X.

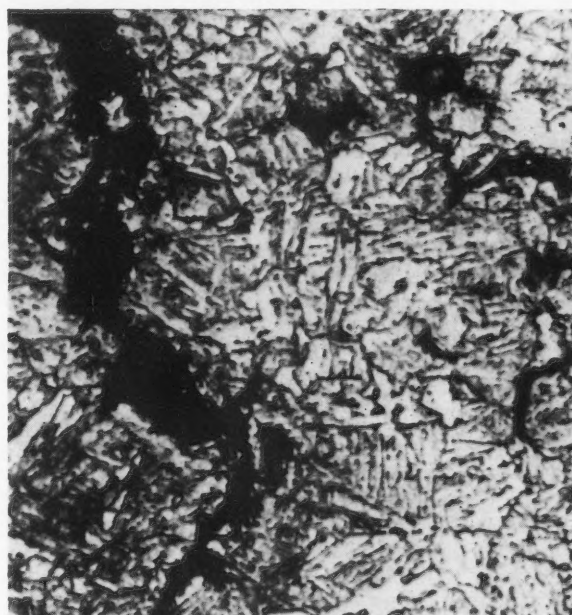
Figure 3—Cracking on 9 percent nickel steel by cathodic pickling. Nital etch. 200 X.

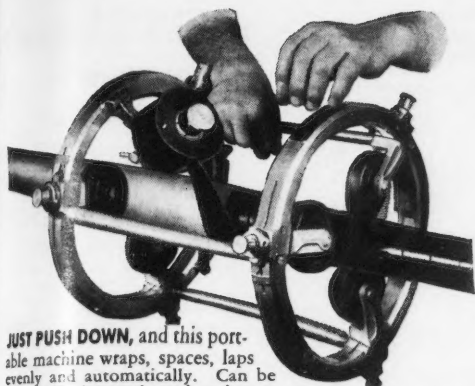
**JUST PUSH DOWN**, and this portable machine wraps, spaces, laps evenly and automatically. Can be operated by inexperienced workmen.

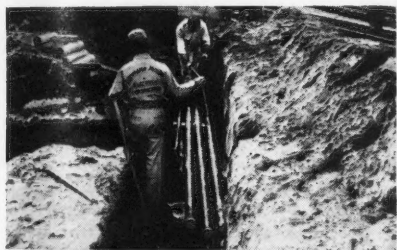
**NO DRYING TIME** with Polyken wrapped pipe. Immediate burial.

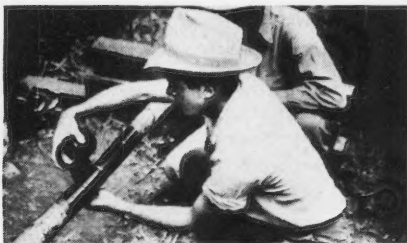
**HAND WRAPPED AT THE JOB**, Polyken is easily applied, even to couplings, joints and elbows. Conforms to odd-shaped surfaces.

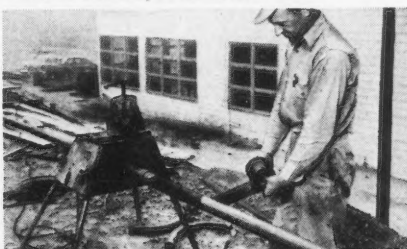
**PORTABLE PIPE MULE** turns the pipe, speeds the job, cuts costs.

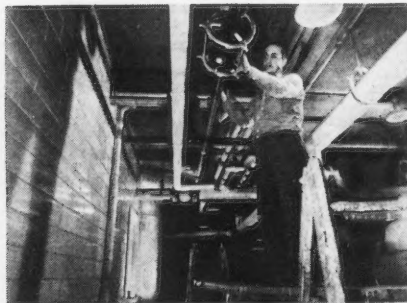
**ON OVERHEAD PIPES ALREADY IN PLACE**, Polyken wraps on quickly with this simple machine.

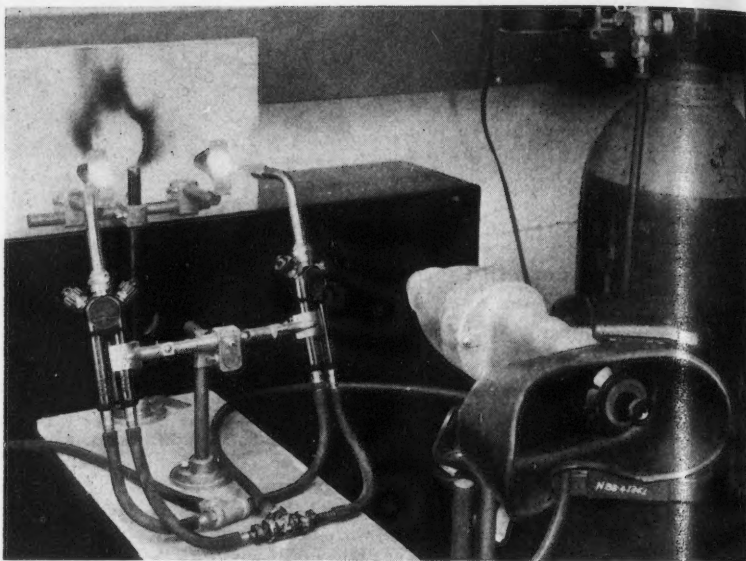
Figure 1—Apparatus for flame-testing coated molybdenum specimens at the National Bureau of Standards. Specimen surface temperatures, which ranged from 2000 to 3000 degrees F, were observed by means of an optical pyrometer (right of center). Chromium-frit coatings were found to add substantially to the life of the molybdenum.

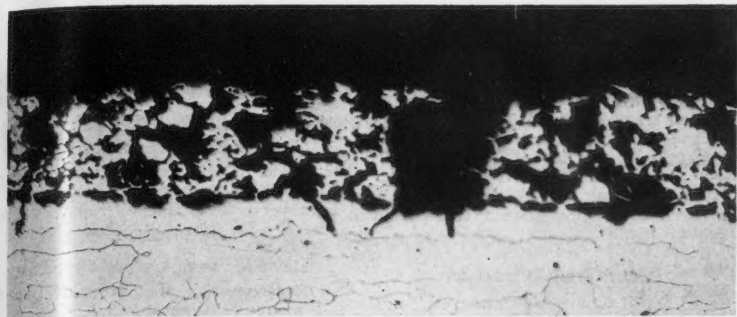
Figure 2—Photomicrograph of molybdenum specimen coated with glass seal-coat M-13 on top of chromium-frit coating M-39. The specimen was subjected to thermal shock for 25 cycles from 1800 degrees F prior to sectioning. The glass seal-coat apparently tended to seal thermal-shock cracks that developed in the base coat. Top (dark grey) layer: plastic mount. Second (narrow black) layer: glass seal-coat. Third (variegated grey-and-white) layer: chromium-frit coating. Fourth (narrow white) layer: diffusion layer. Bottom (near-white) layer: molybdenum. (X150, etched in nitric acid.)

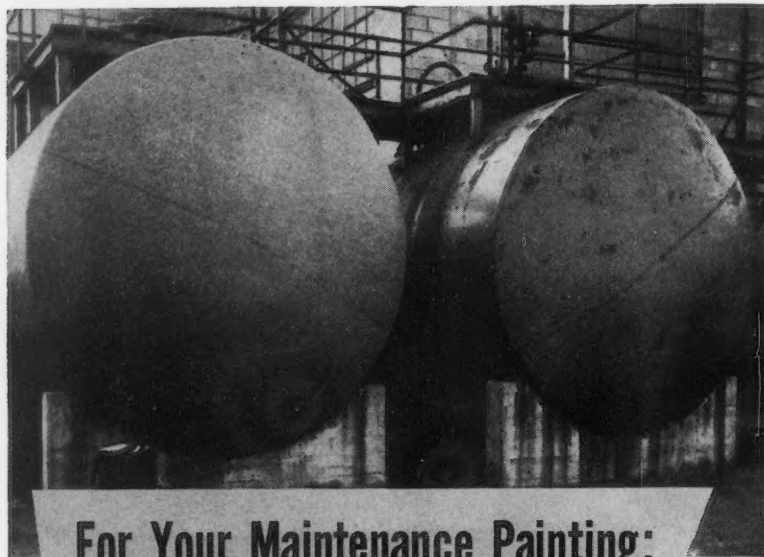
Left Tank: 10-mil thickness of protective coating after 3 years' service.

Right Tank: 3-mil thickness of same system failing after 2 years.

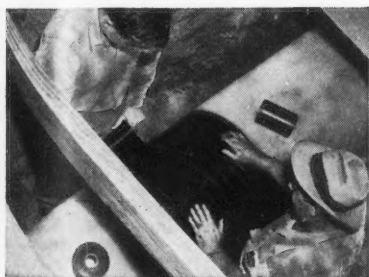
**TRANTEX® TAPE** simplifies coating of welded joints of mill-wrapped pipe—shields the pipe against corroding agents.

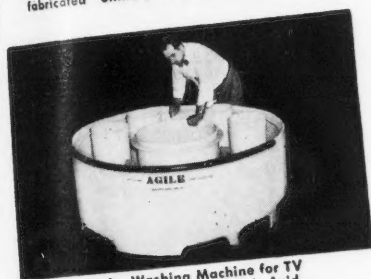
Substructure of a Washing Machine for TV Picture tubes, containing Hydrofluoric Acid, fabricated throughout from AGILENE.

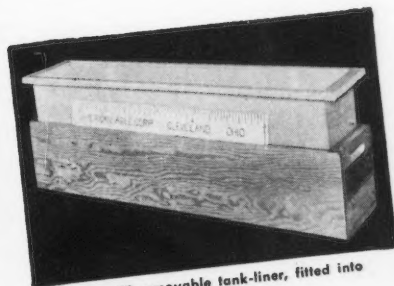
AGILENE removable tank-liner, fitted into a plywood case.

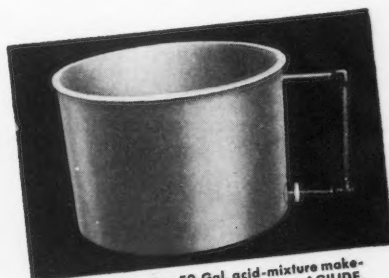
Self-supporting 50-Gal. acid-mixture make-up tank, fabricated entirely from AGILIDE, including pipe fittings and flanges.

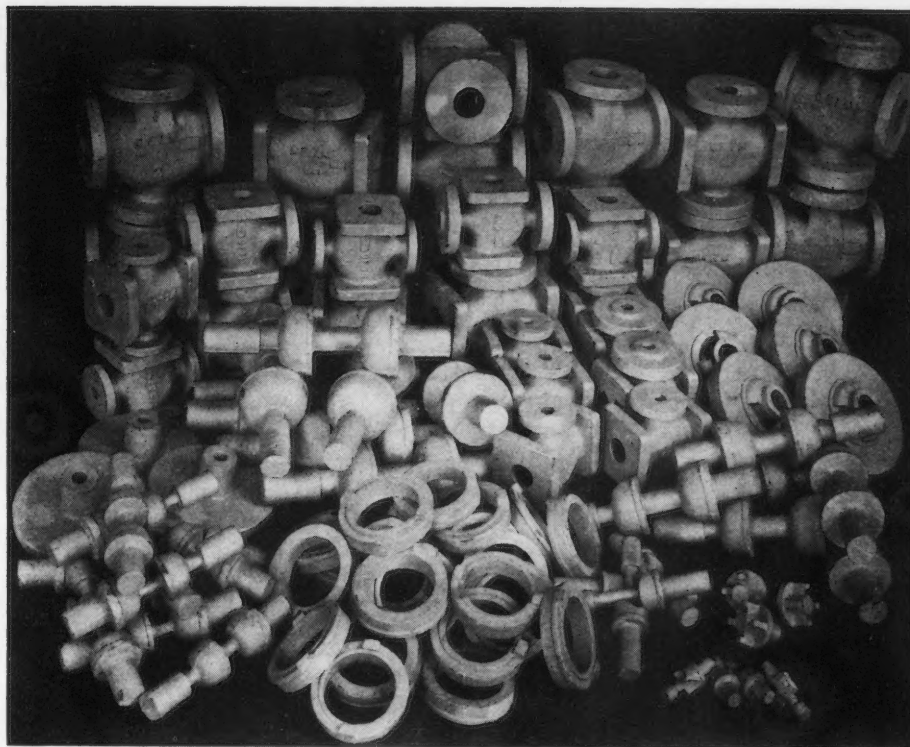
VALVE BODIES AND "TRIM" CAST IN AUSTENITIC CHROMIUM-NICKEL STAINLESS STEEL FOR CORROSION RESISTANCE. Produced by Empire Steel Castings, Inc., Reading, Pa., for Kieley and Mueller, Inc., North Bergen, N. J., these stainless steel castings provide 80,000 p.s.i. tensile strength, 40,000 p.s.i. yield strength, 50% elongation, hardness of 156 BHN.
